# JCM Industries, Inc.

## **JCM 114 Series FABRICATED MECHANICAL JOINT ENCAPSULATION FITTINGS**

**JCM 114 Mechanical Joint Bell Repair Sleeve**

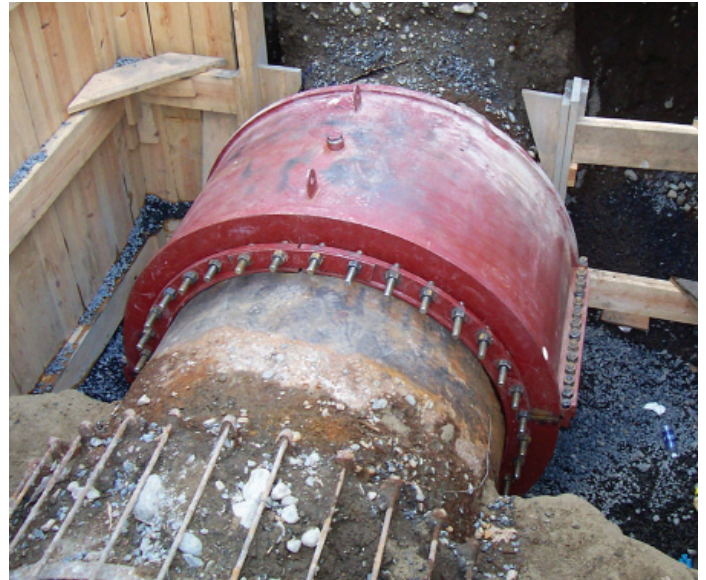
JCM Series 114 Mechanical Joint Repair Sleeves are ideal for situations that involve damaged pipelines or leaking pipeline appurtenances. The JCM 114 Series is a unique and versatile fitting that lends itself to be the permanent solution to complicated issues. The JCM 114 Series offers:

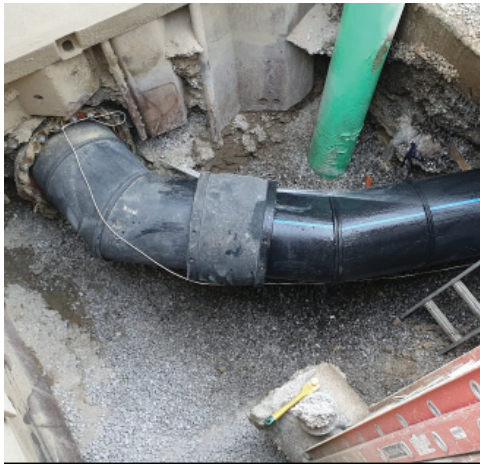
**CASE STUDY NO. 1 - Leaking HDPE Fused Coupling on 22" Pipe.**

This application challenged JCM with a leaking electro fusion coupling on 22" HDPE Pipe, JCM submitted the 114 Mechanical Joint Bell Repair Sleeve style sleeve to make the repair.

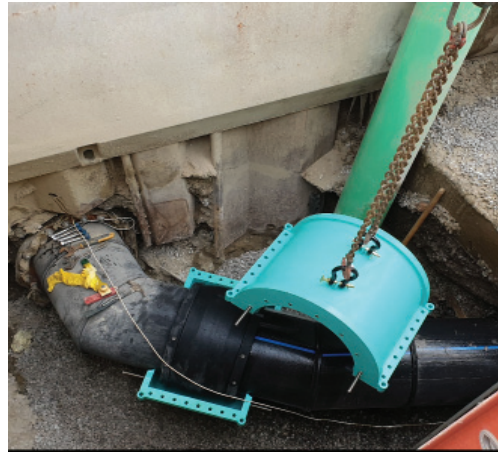
Shown above, the 114 Bell Repair design has an expanded middle section that accommodates the outside diameter and laying length of the coupling with end flanges that transition down to fit on the outside diameter of the pipe. As a mechanical joint fitting, the 114 has both sidebar gaskets and end gaskets that provide the watertight seal around the leaking coupling.

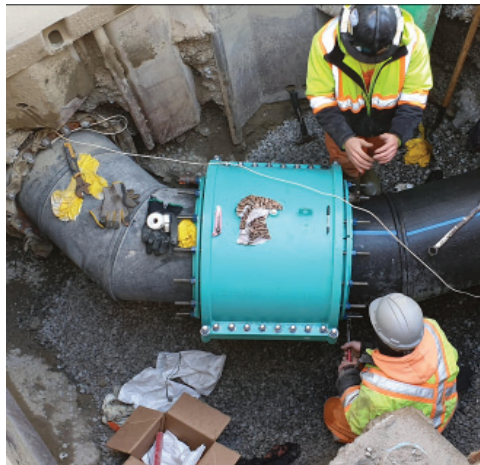
Above, the mechanical joint followers are installed on the left side of the fitting and technicians finish up the installation by installing and tightening the mechanical joint follower bolts on the right side.

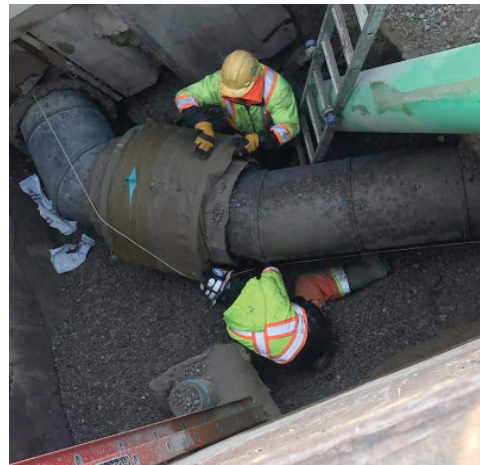
At the completion of the installation, technicians add to the corrosion resistance of the epoxy coated fitting by wrapping the entire unit in additional protective material.

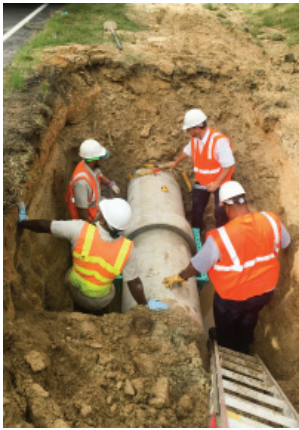
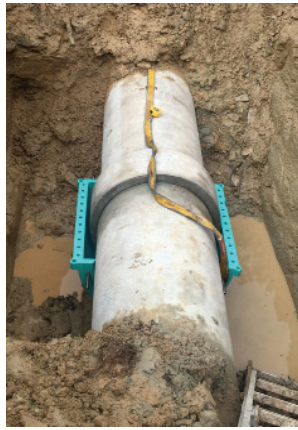
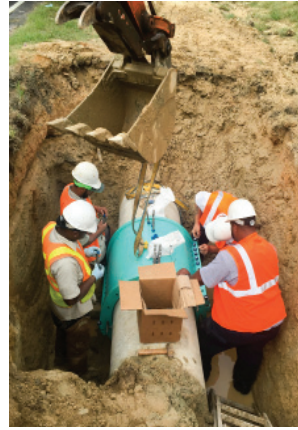
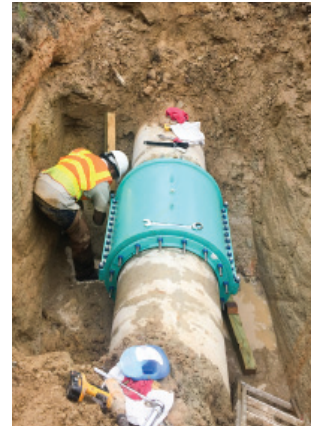
**CASE STUDY NO. 2** - Henderson, North Carolina experienced a 24" leaking Asbestos Cement Pipe Coupling. A previous leaking coupling was repaired by taking the line out of service, cutting out the coupling and installation a replacement piece of pipe. Taking that line out of service was an inconvenience to system users and required time to draining the line and excessive loss of treated water. Using the JCM 114 Mechanical Joint Bell Repair Sleeve reduced labor time, kept the line in service and will last the life of the pipeline. For the complete story of this installation, scan QR code:

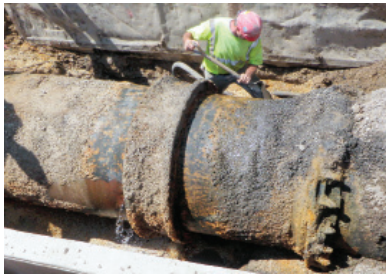
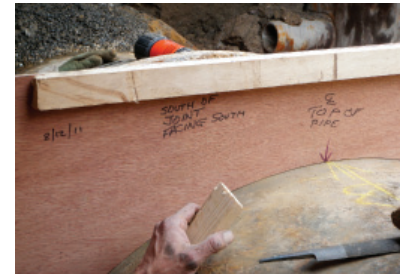
**CASE STUDY NO. 3** - A midwestern municipality with a leaking lead joint coupling exposed the location, photographed, measured and submitted a job site sketch for the repair. The data submitted indicated that the coupling maximum diameter varied slightly on each raised lip and pipe diameters on each side of the coupling had a variance of approximately .45 of an inch. The experienced utility supervisor and his team created a "template" of the repair area to ensure that the fabricated fitting would accommodated out of round/flat spots on the pipe diameter.

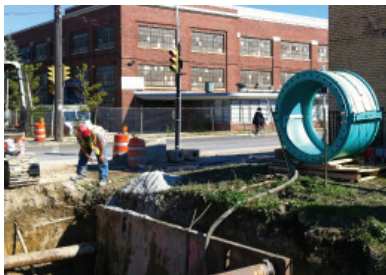
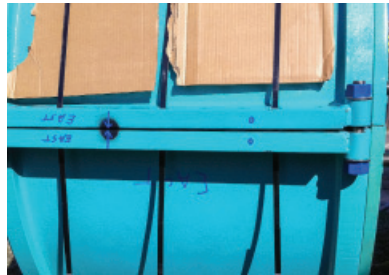
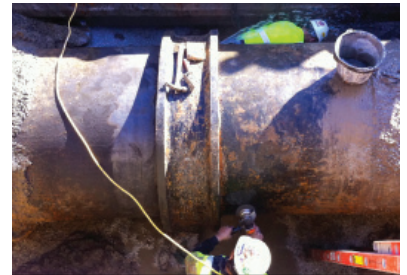
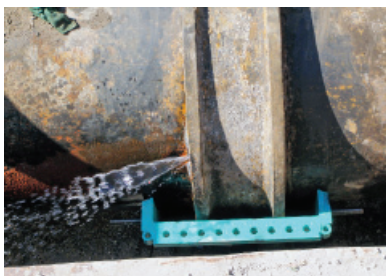
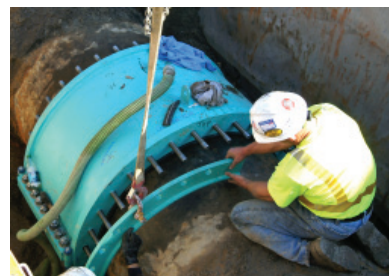
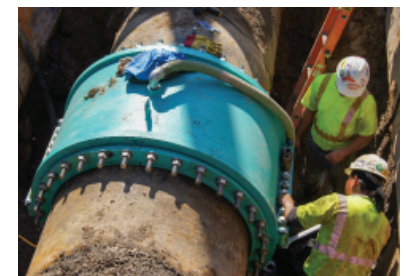
Upon arrival at the jobsite, the utility supervisor measured and marked the sleeve with location orientation notes for pipe O.D.s to ensure correct placement on the pipe. Pipe preparation including cleaning, buffing the cast iron surface to ensure that the gasket has a debris-free sealing surface. Note the bottom left photo - how the JCM 114 Mechanical Joint Bell Repair Sleeve encapsulates the failed coupling in the body cavity. Side gaskets (set in groove in the top half) and the end mechanical joint gasket configuration provide the water tight seal for the entire repair area.

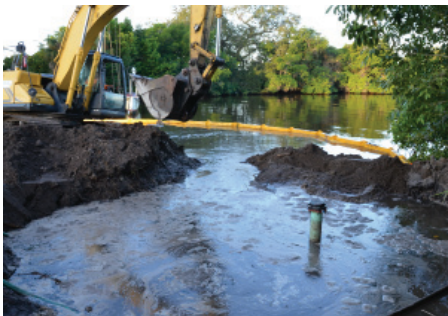
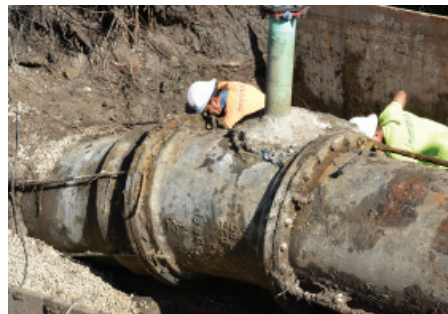
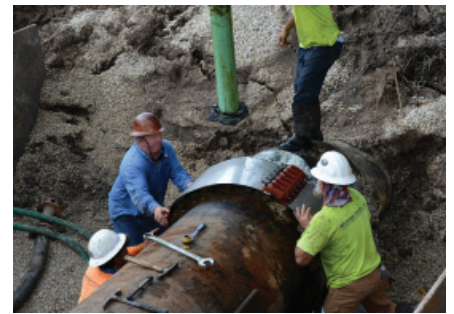
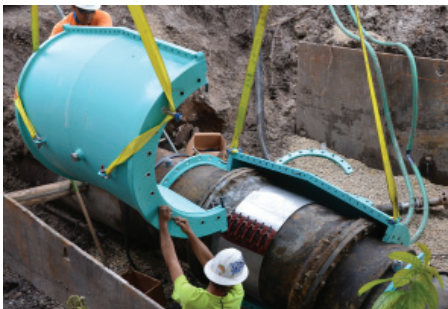
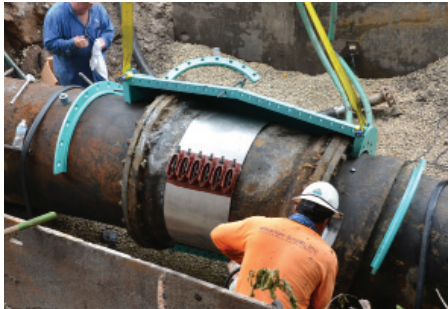
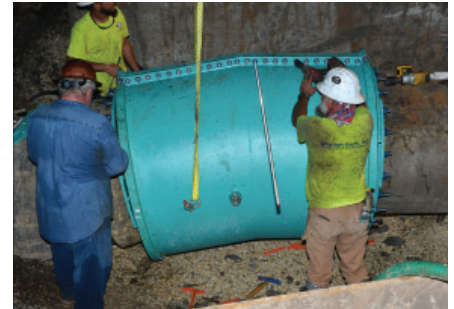
Installation Day: excavation and preparation of the repair area, assessment of dimensions and space restraints, removal of riser and repair of hole, and installation of the MJ fitting solved the leak and ensured uninterrupted service for the pipeline.

**CASE STUDY NO. 4** - A Florida municipality was challenged by a leaking 36" cast iron 11.25° mechanical joint fitting. Prior to ordering, city staff excavated the line to determine the source and type of leak and assess the needs for the repair. Staff members made field measurements of the pipe and the fitting. The on-site staff member who recorded the information contracted the COVID-19 virus after the measurements were completed. Alternate staff members provided information to the local distributor & JCM Industries – but as those personnel were not on-site during excavation of the line, there were several difficulties in the connection assembly that was not furnished to the distributor or JCM.

1. Outlet/riser to be removed.
2. The very, very short distance between the elbow MJ pusher gland and a pipe bell/spigot connection.
3. Restraint rods completing the installation
