**JCM 114 Series
FABRICATED MECHANICAL JOINT
ENCAPSULATION FITTINGS
Permanent Repair
of HIGH DENSITY POLYETHYLENE PIPE
for
Severly Damaged Pipe
Leaking Flanged Connections
Failed Fusion Joints
Full Sections of Damaged Pipe
Over Temporary Repair Units
and others**

JCM 6114 All 316 Stainless Steel Repair Sleeve

CASE STUDY NO. 1

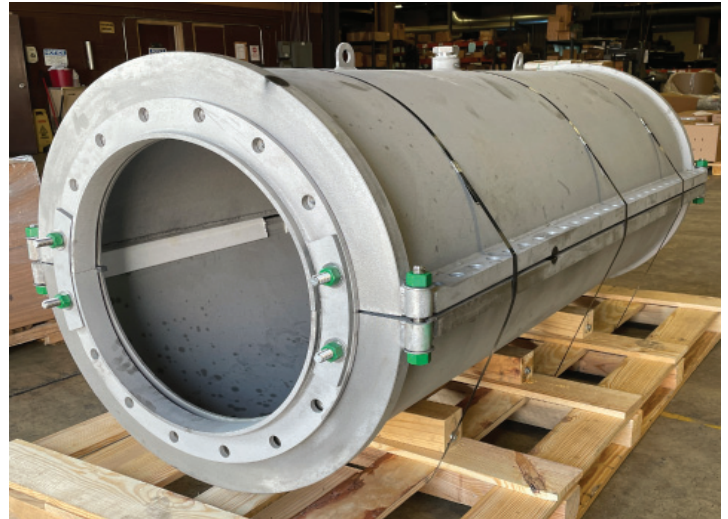
JCM Series 114 Mechanical Joint Repair Sleeves are ideal for situations that involve damaged pipelines or leaking pipeline appurtenances. The JCM 114 Series is a unique and versatile fitting that lends itself to be the permanent solution to complicated issues. The JCM 114 Series offers:

Available in Three Styles - the 114 MJ Split Repair Sleeve for use on straight runs of pipe and the 114 MJ Bell Repair Sleeve which is fabricated to accommodate the specific dimensions of the coupling or appurtenance to be repaired. The JCM 114 MJ Repair Sleeve can also be fabricated to accommodate two different O.D.'s of pipe.

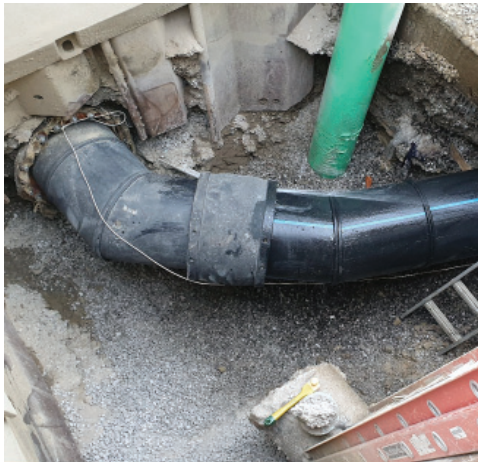
This application challenged JCM with a leaking electro fusion coupling on 22" HDPE Pipe, JCM submitted the 114 Mechanical Joint Bell Repair Sleeve style sleeve to make the repair.

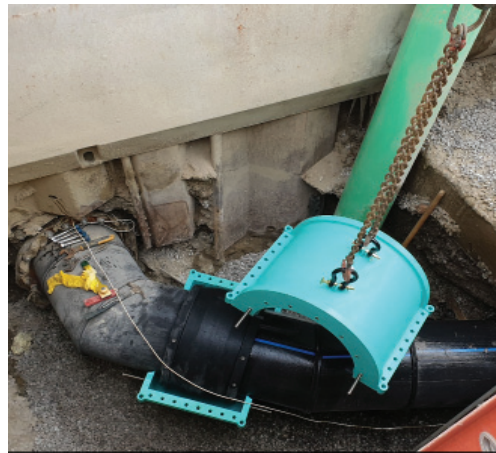
Shown above, the 114 Bell Repair design has an expanded middle section that accommodates the outside diameter and laying length of the coupling with end flanges that transition down to fit on the outside diameter of the pipe. As a mechanical joint fitting, the 114 has both sidebar gaskets and end gaskets that provide the watertight seal around the leaking coupling.

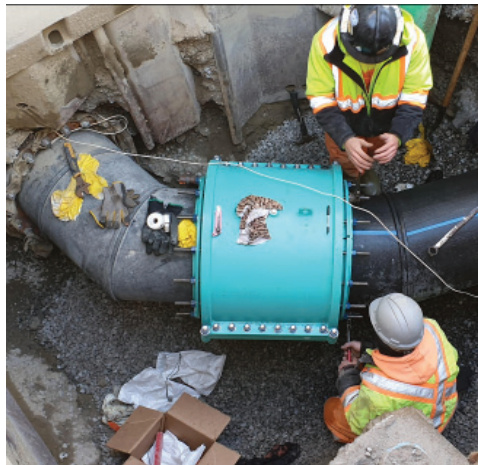
Above, the mechanical joint followers are installed on the left side of the fitting and technicians finish up the installation by installing and tightening the mechanical joint follower bolts on the right side.

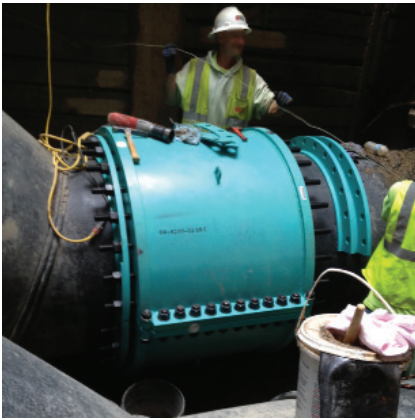
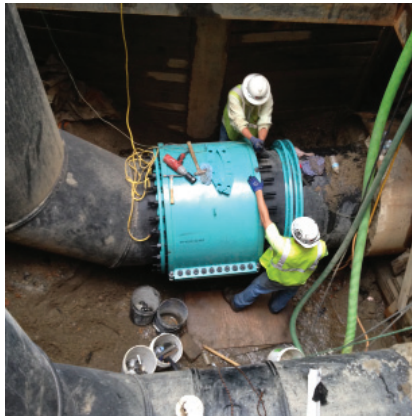
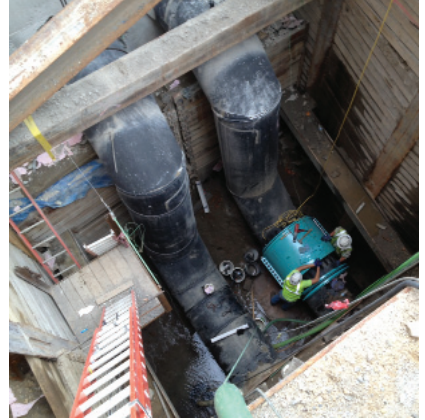
CASE STUDY NO. 2 - Unlike the repair over the leaking electro fusion coupling, this encapsulation fitting was provided as a permanent “standby” repair fitting.

The inspector of this project felt the fused joint may be suspect and to ensure a a leak free system for the future, the pipeline owner decided to have the JCM 114 Mechanical Joint Repair Sleeve for a straight run of pipe installed so in the event of any failure of the fused joint, the 114 was in place - preventing any need for reexcavation of the pipeline in the very deep vault area. The pipe is 42” IPS Sized HDPE.

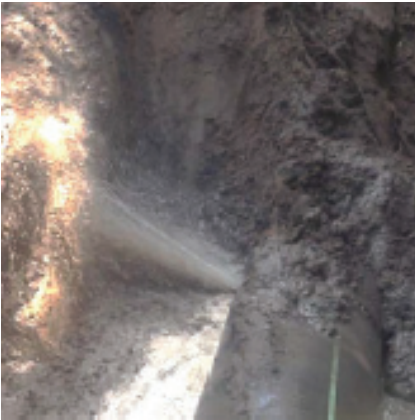
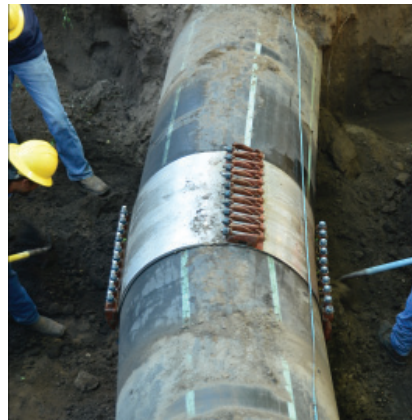
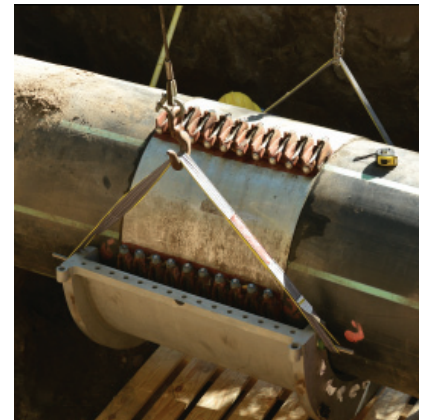
CASE STUDY NO. 3 - A Florida utility district discovered a failure at a butt-fused joint on 36” HDPE Force Sewer Main. As a temporary repair, the utility installed a JCM 102-3600-18 Extended Range Universal Clamp Coupling while a permanent solution was considered. The temporary repair served for four (4) years. This pipeline was considered “critical” and the utility was unable shut the line down. Considering all the parameters, the JCM 114 Bell Repair Sleeve was selected (the Bell Repair design accommodated the encapsulation of the repair clamp) and provided a complete seal of the area with side and end gaskets. To ensure a repair to last the life of the pipeline, the 114 was fabricated of all 316 stainless steel (JCM Model 6114) and the restraint system included was also of all 316 stainless steel.

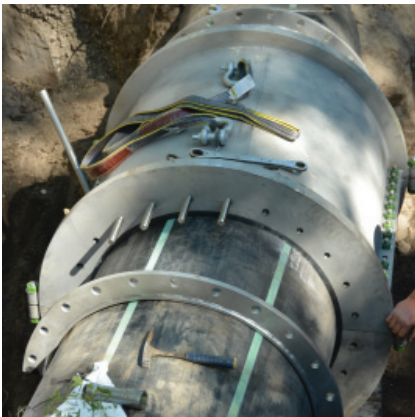
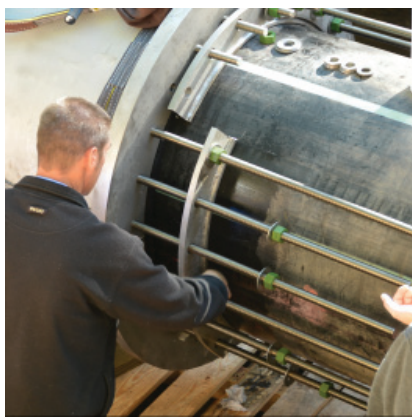
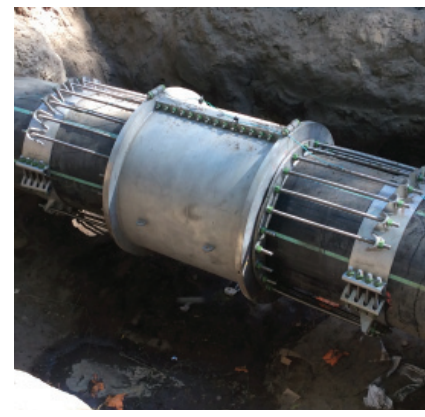
Due to the curvature of the pipeline, some job-site modifications of the JCM 6114 were performed to ensure the fitting sealed the mechanical joint ends. These field adjustments were possible, as the 6114 is a fabrication rather than a cast iron fitting. After completing the sleeve installation, technicians installed the restraint system on each side of the repair area to prevent axial movement of the pipeline and relieve stress at the damaged area - also preventing additional damage severity.

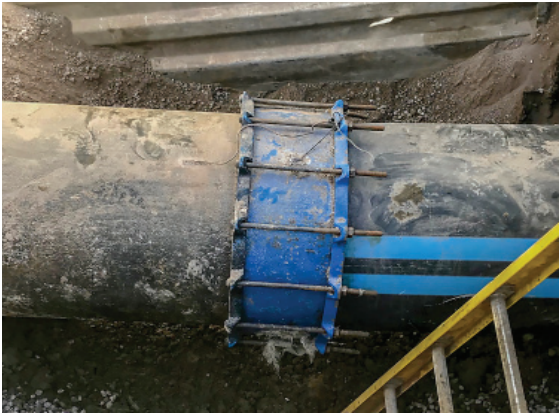
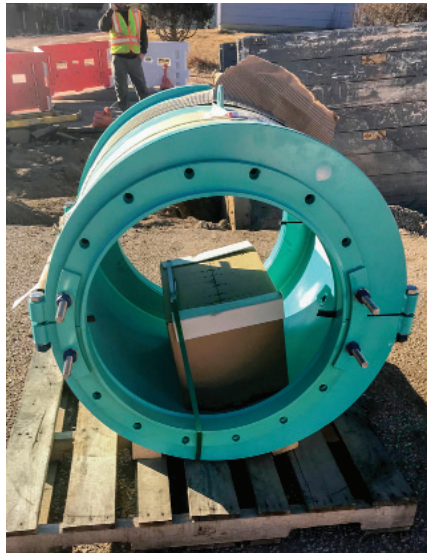
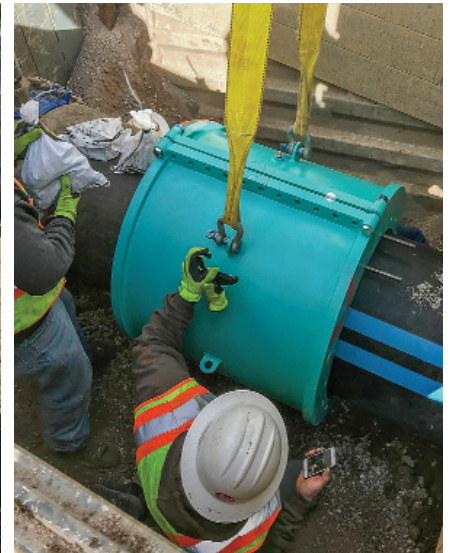
CASE STUDY NO. 4 - A reported leak on Christmas Day was from a 24" bolted coupling joining HDPE to Cast Iron Pipe. This application was installed several years prior to the leak and over time settlement had taken a toll on the connection, causing the pipe to shift and push the coupling beyond it's deflection capability. Several traditional solutions were considered with factors such as out of service, discharge mitigation, limited space and time. Ultimately the encapsulation fitting was determined to be the best course of action as it could be installed while the system was in service, within the limited space of the excavated site and with expedited fabrication delivery was limited to days rather than weeks.

The utility performed a 3D scan of the location, worked from a 3D autocad drawing and provided this information to JCM for the permanent fabricated repair sleeve.

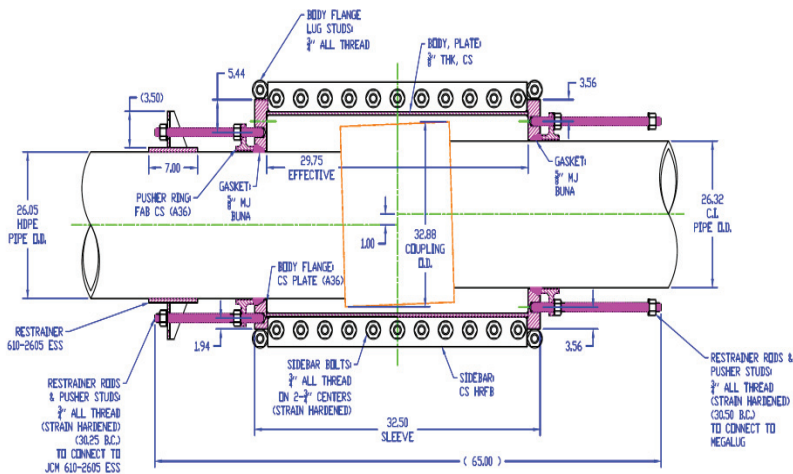
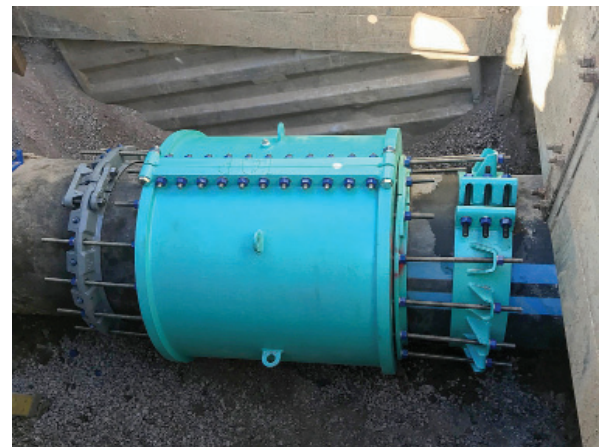
Using this data, JCM engineering team designed a repair fitting that would accommodate the severe offset between the two pipe sections, encapsulate the leaking coupling and provide service for 250PSI working pressure.

Restraint systems for both types of pipe were installed on the 114 to prevent future pipe movement, relieve stress from the vulnerable coupling joint area and stabilize the connection.
